WEST INDIA GOODS STORE

Salem Maritime
National Historic Site

Historic Structure Report

HISTORIC STRUCTURE REPORT Architectural Data

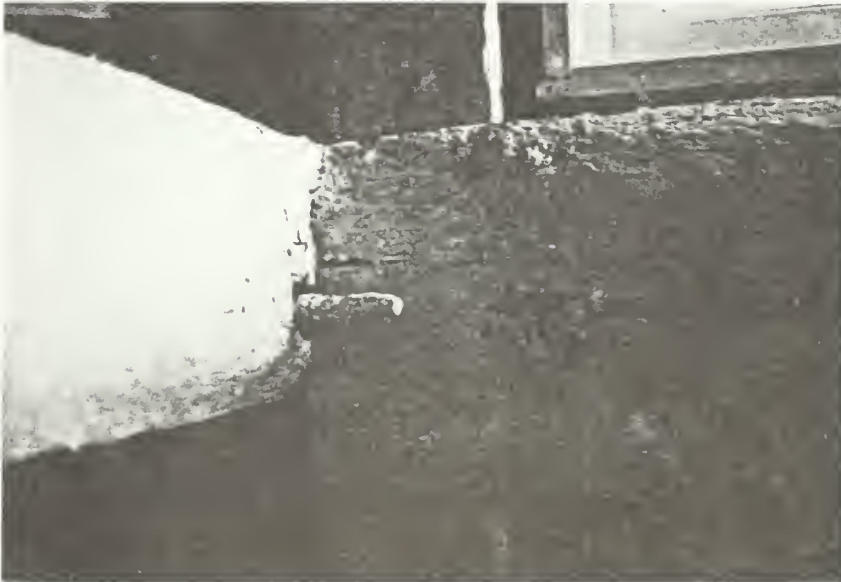
Figure 44. West India Goods Store, interior of second story, west wall looking west, showing pegged post-plate-trussed rafter connection between bays D and E.

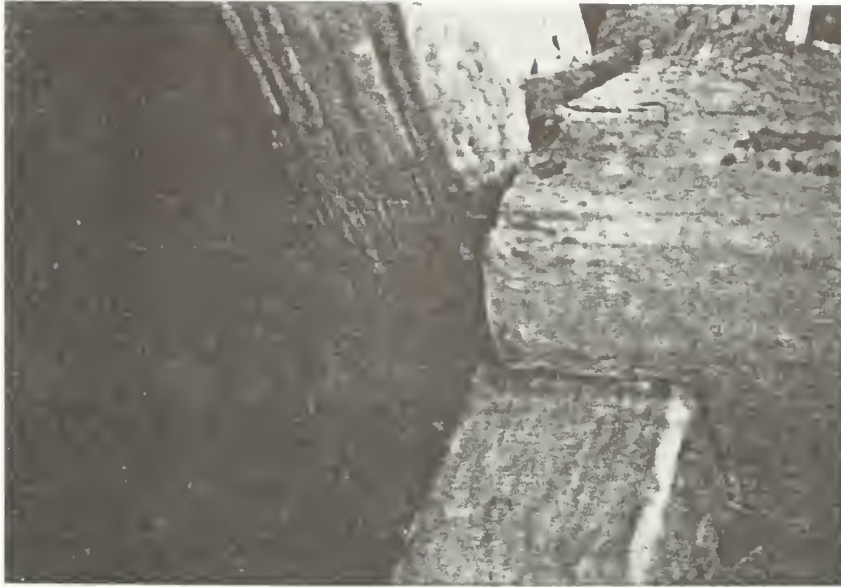
Figure 45. West India Goods Store, interior of second story, west wall looking northwest, showing pegged post-plate-trussed rafter connection between bays D and E. Note builder's mark "III" at corner end of rafter.

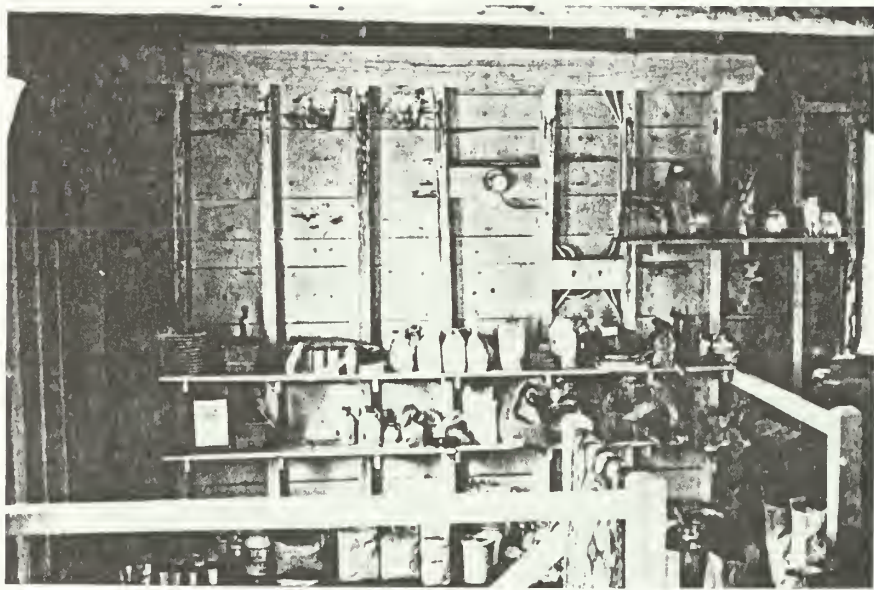
Figure 46. West India Goods Store, interior of second story, north wall, showing modern nominal-dimension lumber construction, stairway railing.

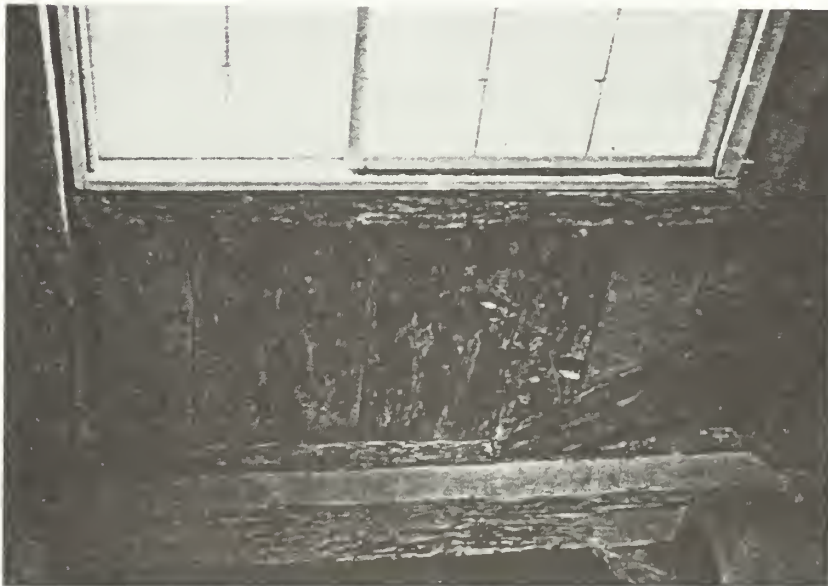
Figure 47. West India Goods Store, interior of second story, east wall, north half of bay B, showing mix of historic and nonhistoric sheathing.

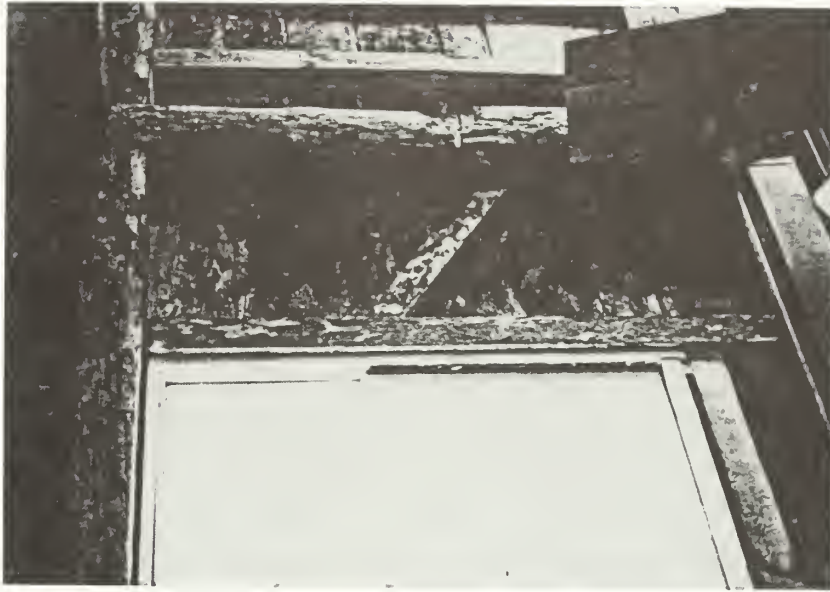
Figure 48. West India Goods Store, interior of second story, east wall, south half of bay B, showing interior sheathing and angled brace that has been cut to accommodate a window.

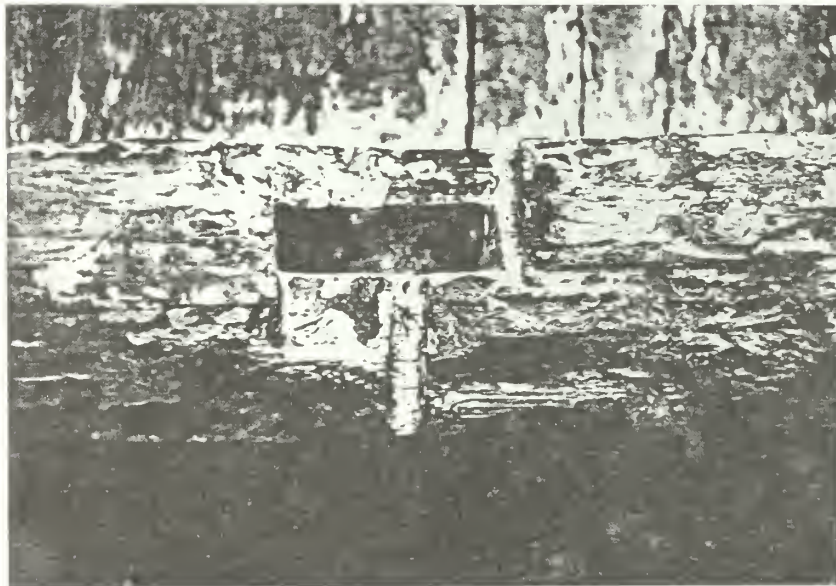
Figure 49. West India Goods Store, interior of second story, east wall looking east, post between bays B and A, showing cut made to accept possible partition framing.

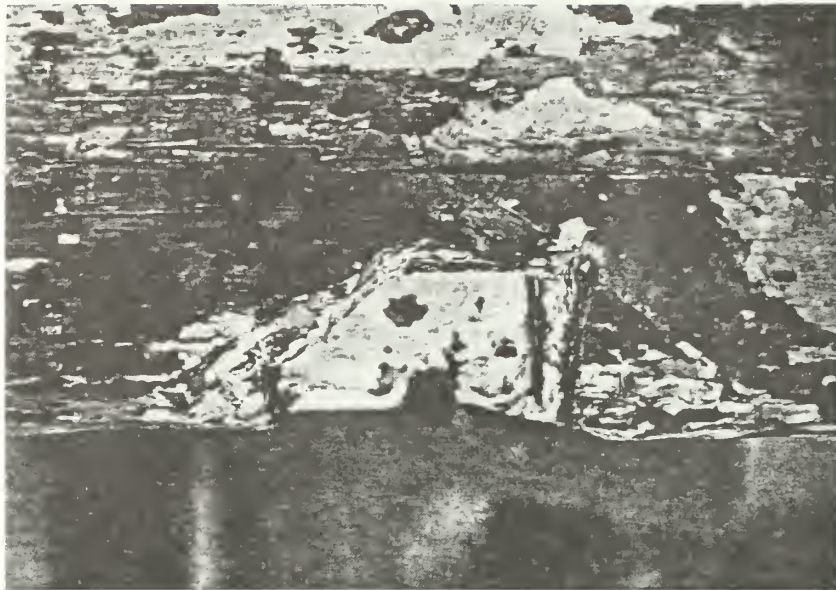
Figure 50. West India Goods Store, interior of second story, east wall looking north, post between bays B and A, showing cut made to accept possible partition framing.

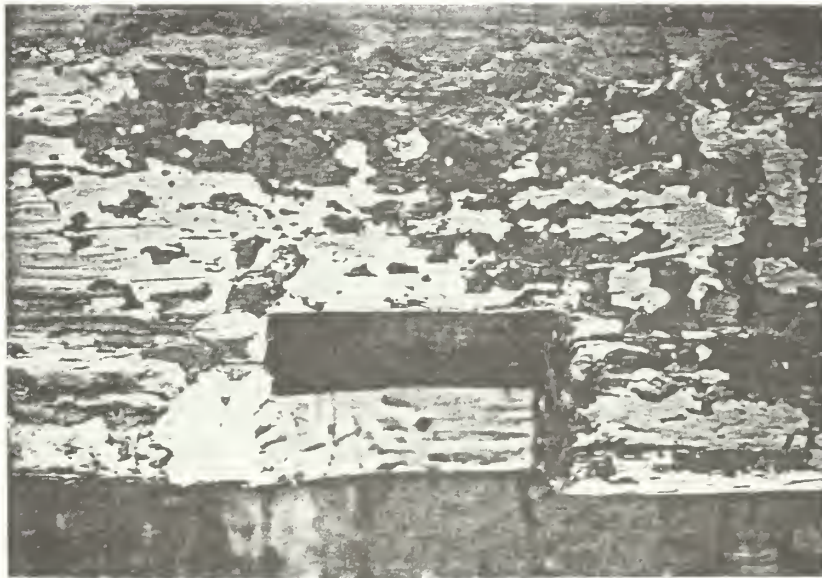
Figure 51. West India Goods Store, interior of second story, west wall looking west, post between bays A and B, showing cut made to accept partition framing.

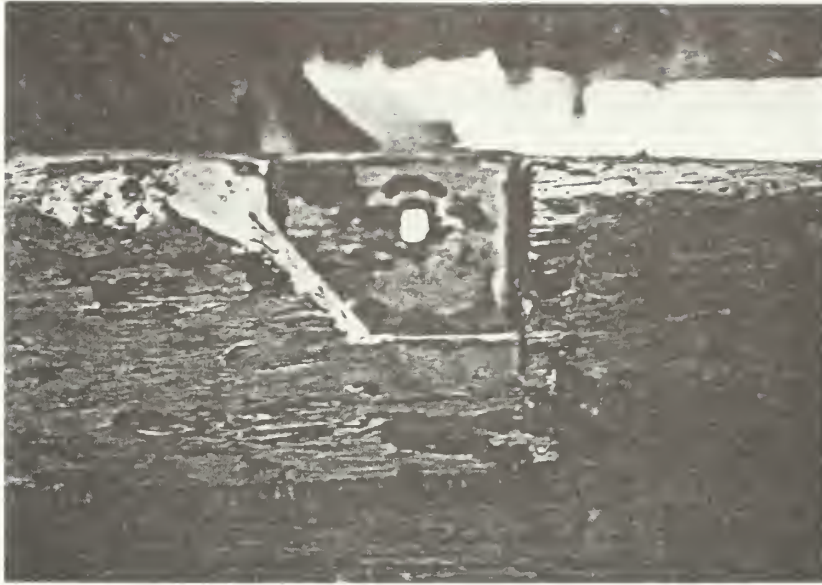
Figure 52. West India Goods Store, interior of second story, west wall looking north, post between bays A and B, showing cut made to accept possible partition framing.

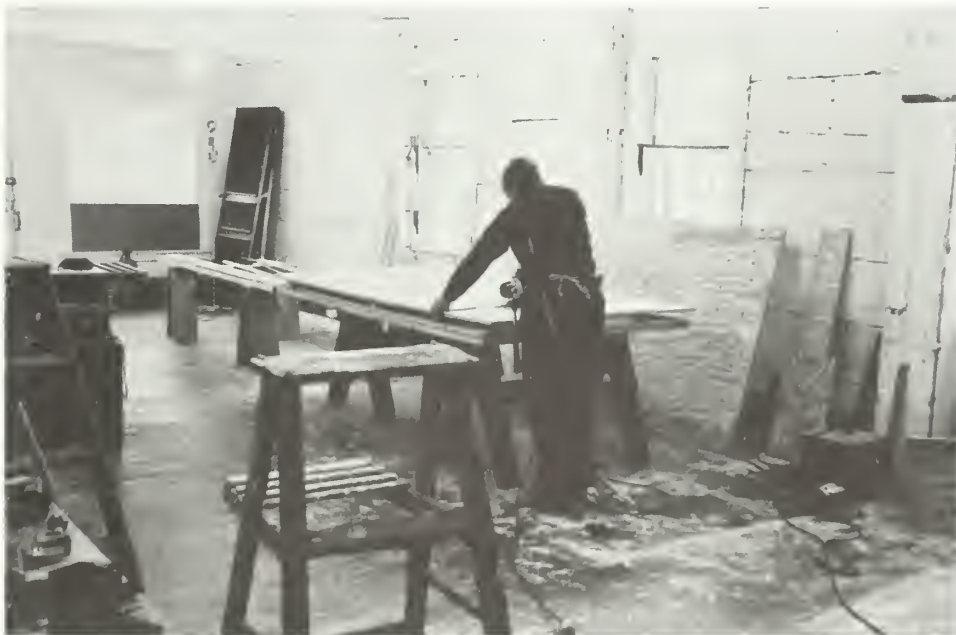
Interior view of first floor looking north showing progress of rehabilitation work.

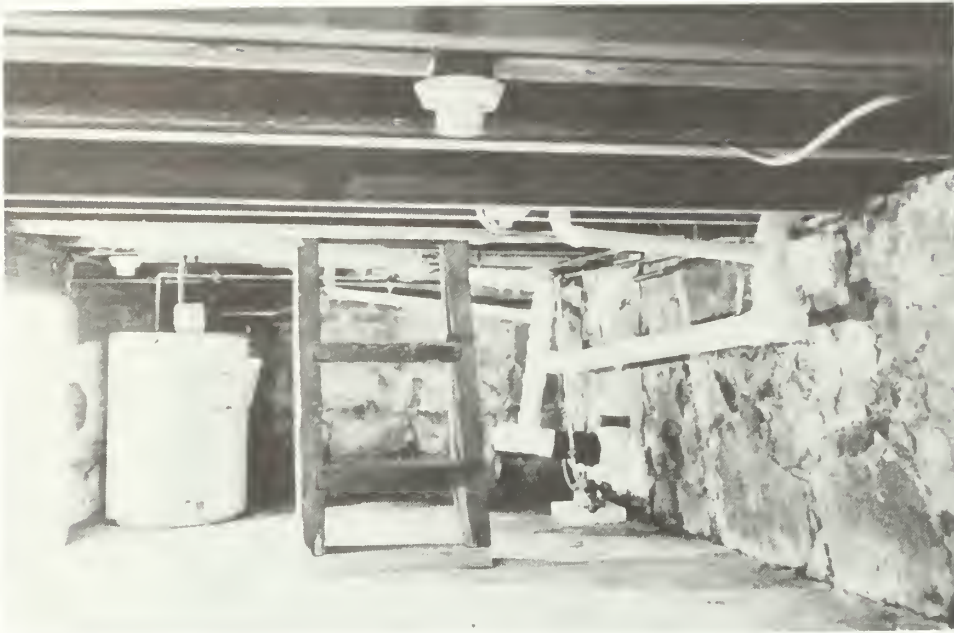
View of crawl space below first floor after the installation of the hot water heater, electrical, plumbing, heating and fire detection systems were completed. View shows east half of crawl space at north end.

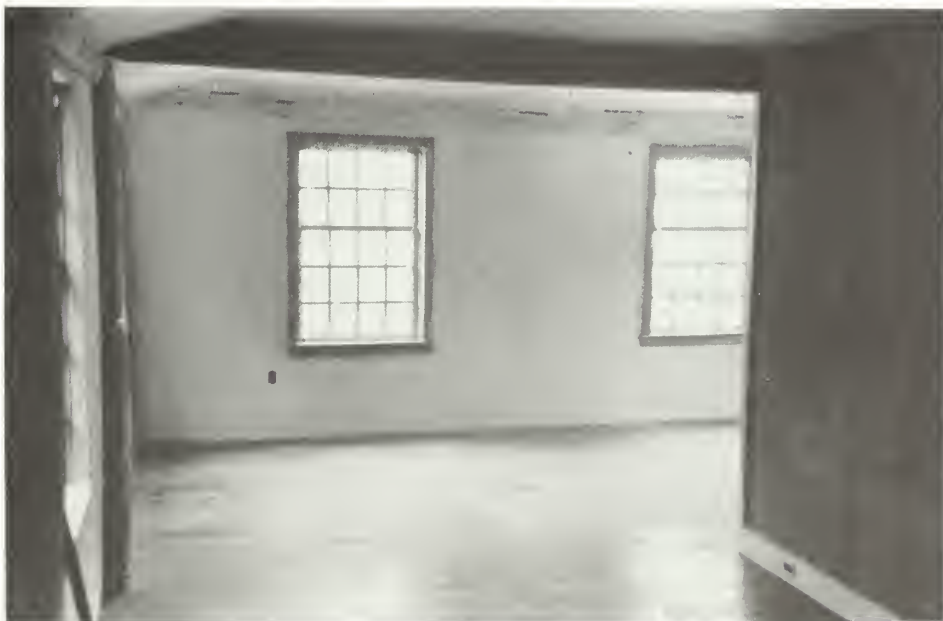
Interior partition, second floor, WIGS, showing rock lath nailed to walls.

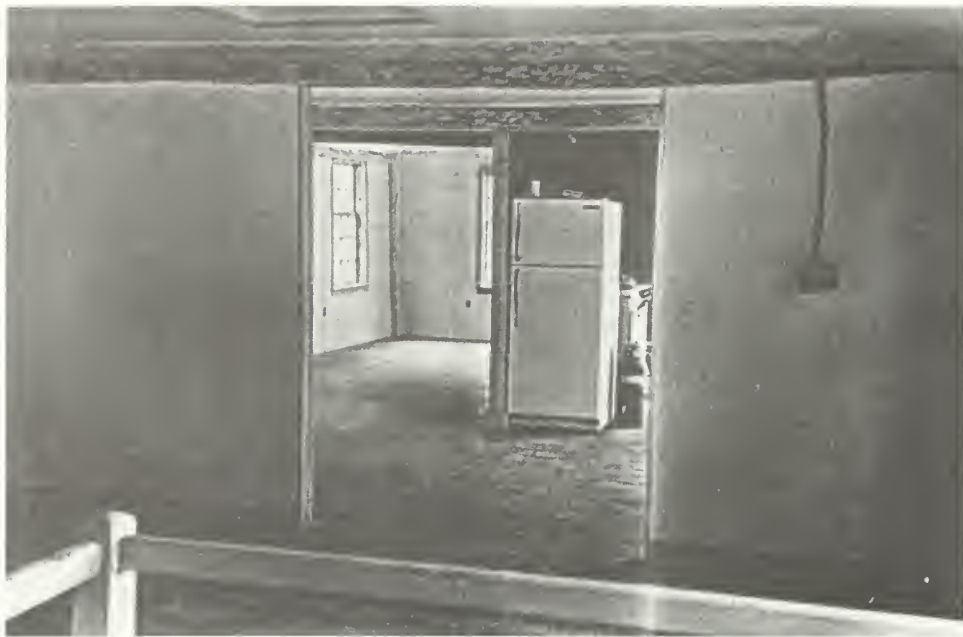
View looking southeast showing newly finished walls,
second floor of WIGS.

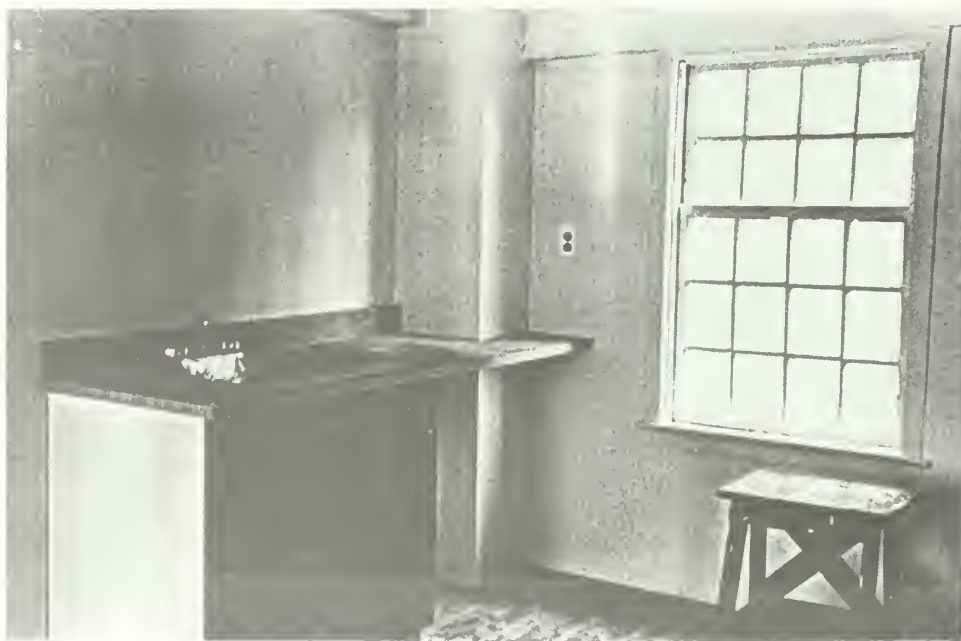
New partition separates a new bathroom and new
Kitchen in north east corner of second floor.
Photograph taken before wall cabinets were
installed.

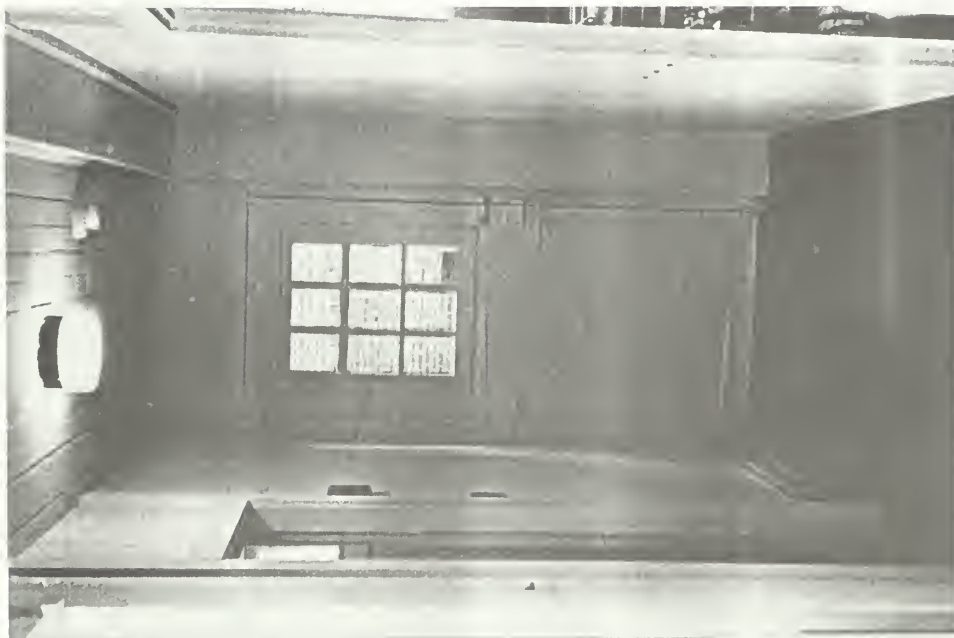
Rear hallway, first floor, WIGS.
Remodeled toilet room on left.

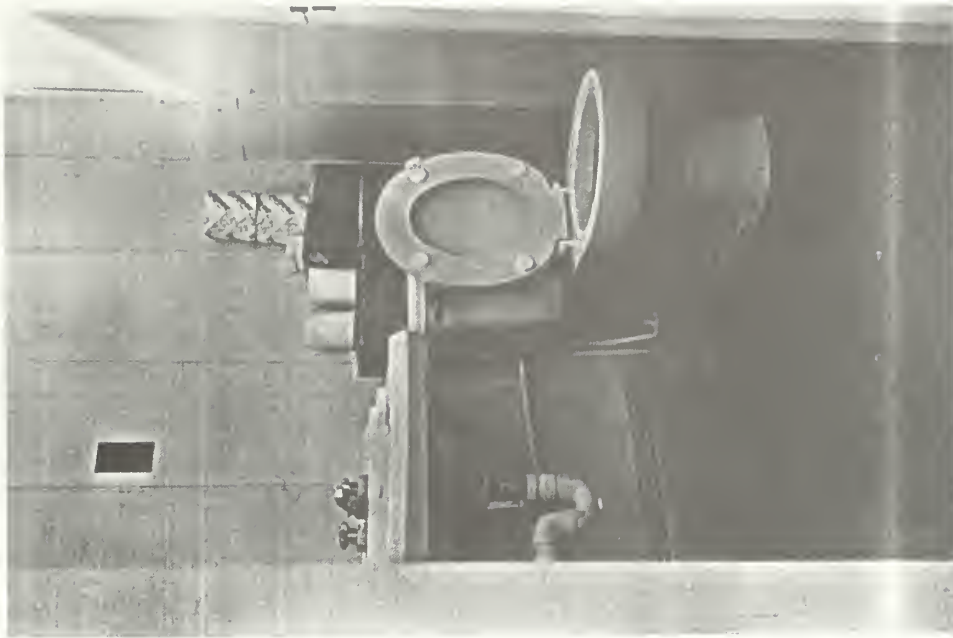
Newly remodeled toilet in northeast
corner of first floor, WIGS.

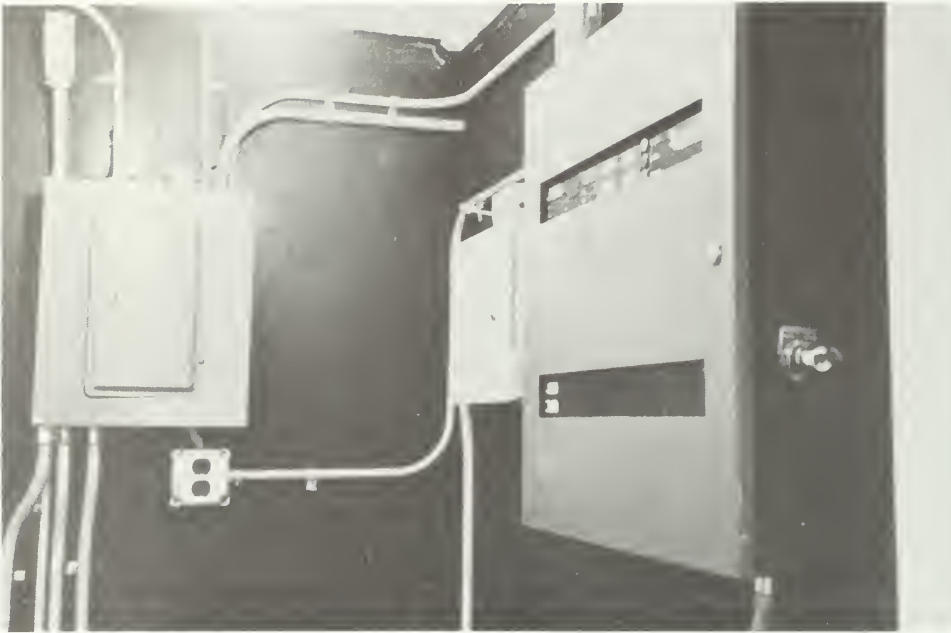
Distribution panels
for electrical, intrusion,
and fire detection systems,
first floor, WIGS.

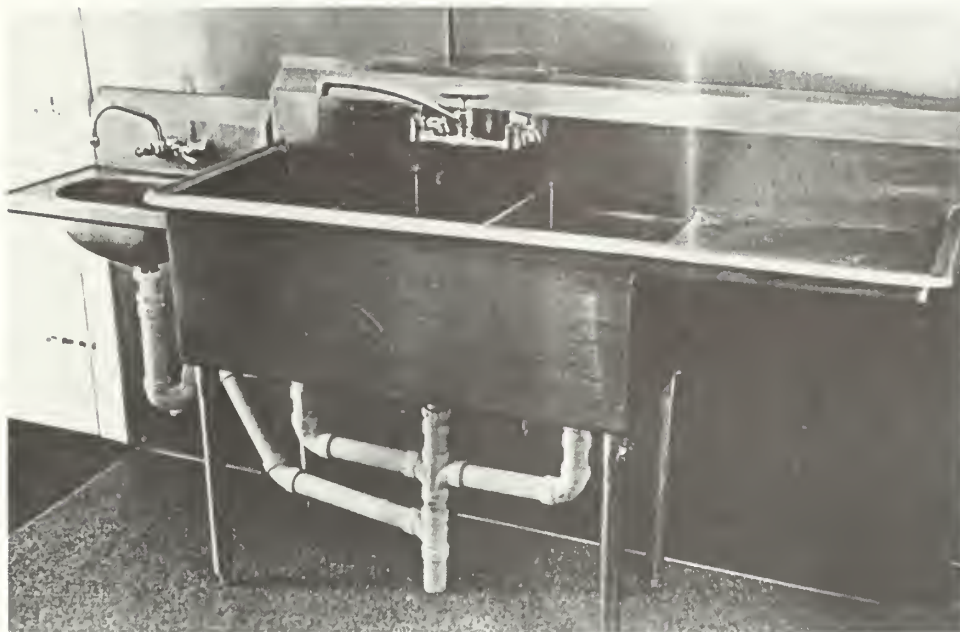
Stainless steel basin
and triple sink with
drain-board installed
in kitchen on first
floor of WIGS.

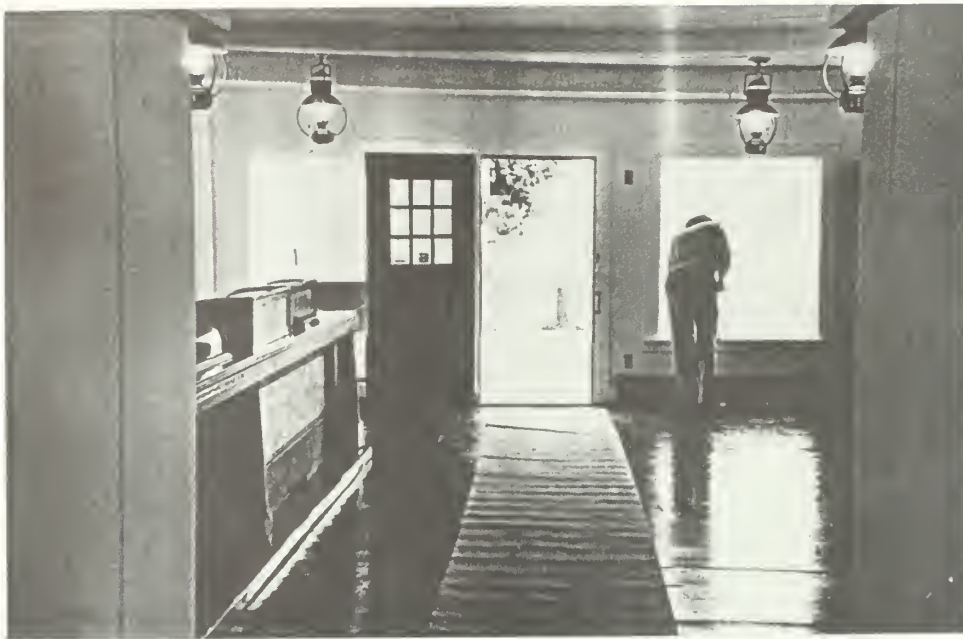
View looking south toward entrance door. Store space is to be operated by Eastern National Parks and Monuments Association.

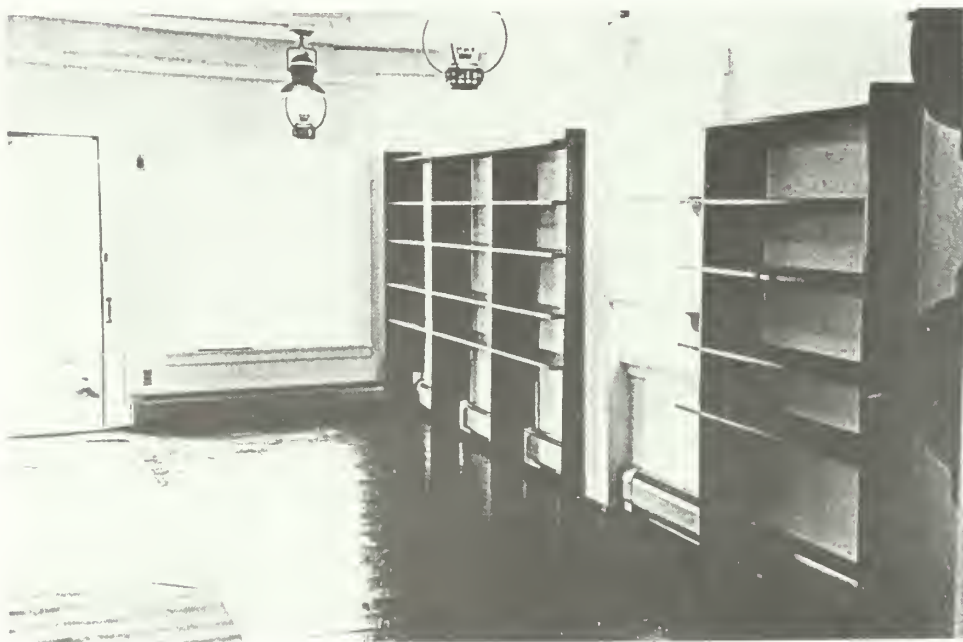
Shelving installed on west wall of store space on first floor.

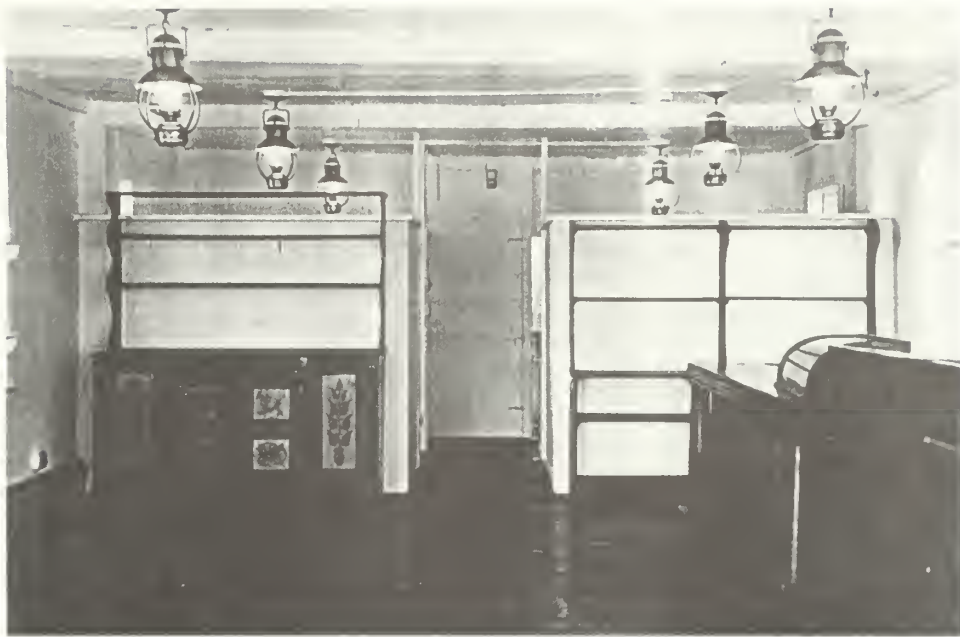
View looking north at West India Goods Store space. Cupboards were removed from the Kitchen of the Derby House and installed at the rear of the storeroom.

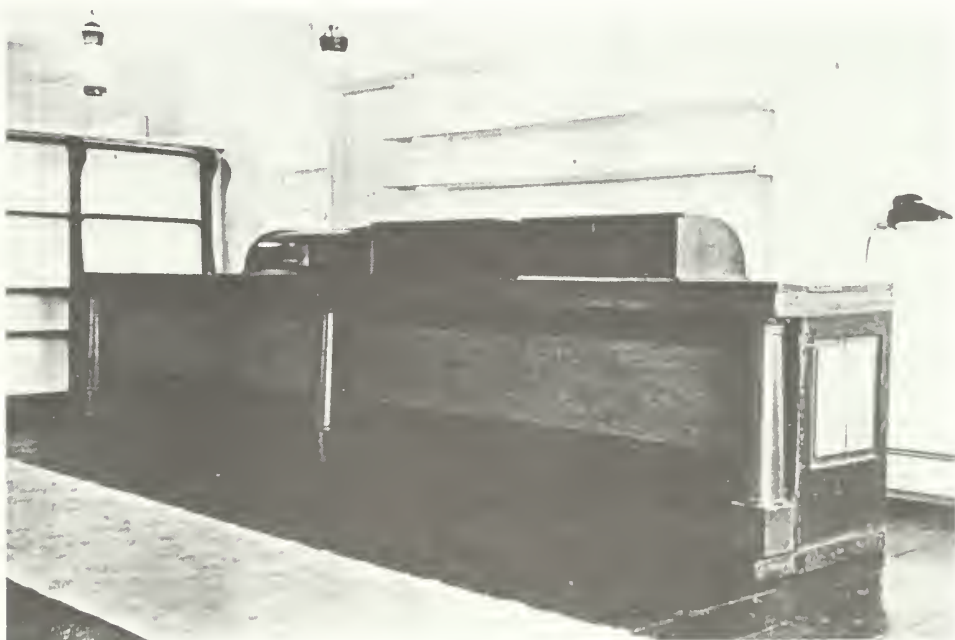
Old counter, left in the store by Mr. Rushford, was re-installed but reduced in height to thirty-six inches.
